DOES YOUR HAMMER CHIP? (A)

Injury from a flying chip from a 20-pound sledge hammer! Why? -- The story of the investigation into the source of the chip.

1977 Written by J. F. Radavich, Material Engineering Department, Purdue University, Lafayette, Indiana and C. O. Smith, College of Engineering and Technology, University of Nebraska, Omaha, Nebraska

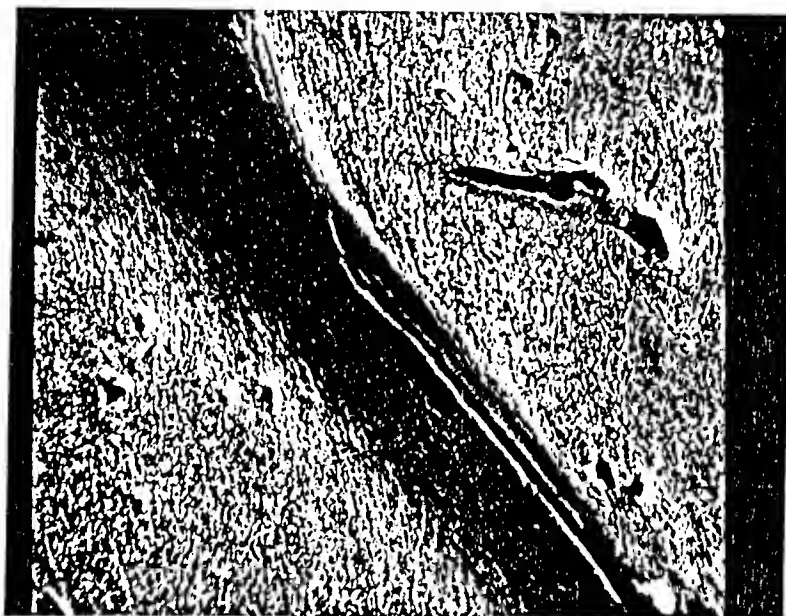
Exhibit A5 Cracks in white layer of Exhibit A4 950X

Samples of material from hammer number 4 and the chip were mounted in bakelite, polished, and etched. Optical and scanning electron microscope studies showed evidence of a white layer or line on the curved side which matched the crater on the hammer. (See Exhibit A3) Other samples from the periphery of the hammer face were prepared in cross sections. Those samples which contained old craters (missing chips) showed a white layer on the surface of the crater while other areas of the edge of the hammer face showed a conical or moon-shaped layer. (See Exhibit A4) Higher magnification of the white layers revealed cracks as shown in Exhibit A5. Exhibit A6 shows a portion of a white layer split from the main edge.
